MANDATORY SERVICE BULLETIN 09-560-01

FROM: JetProp LLC

SUBJECT: Improper Generator Wire Routing Causing Possible Electrical Fire

MODELS AFFECTED: All PA-46-310P/350P aircraft converted to the JetProp configuration in accordance with STC ST0541SE.

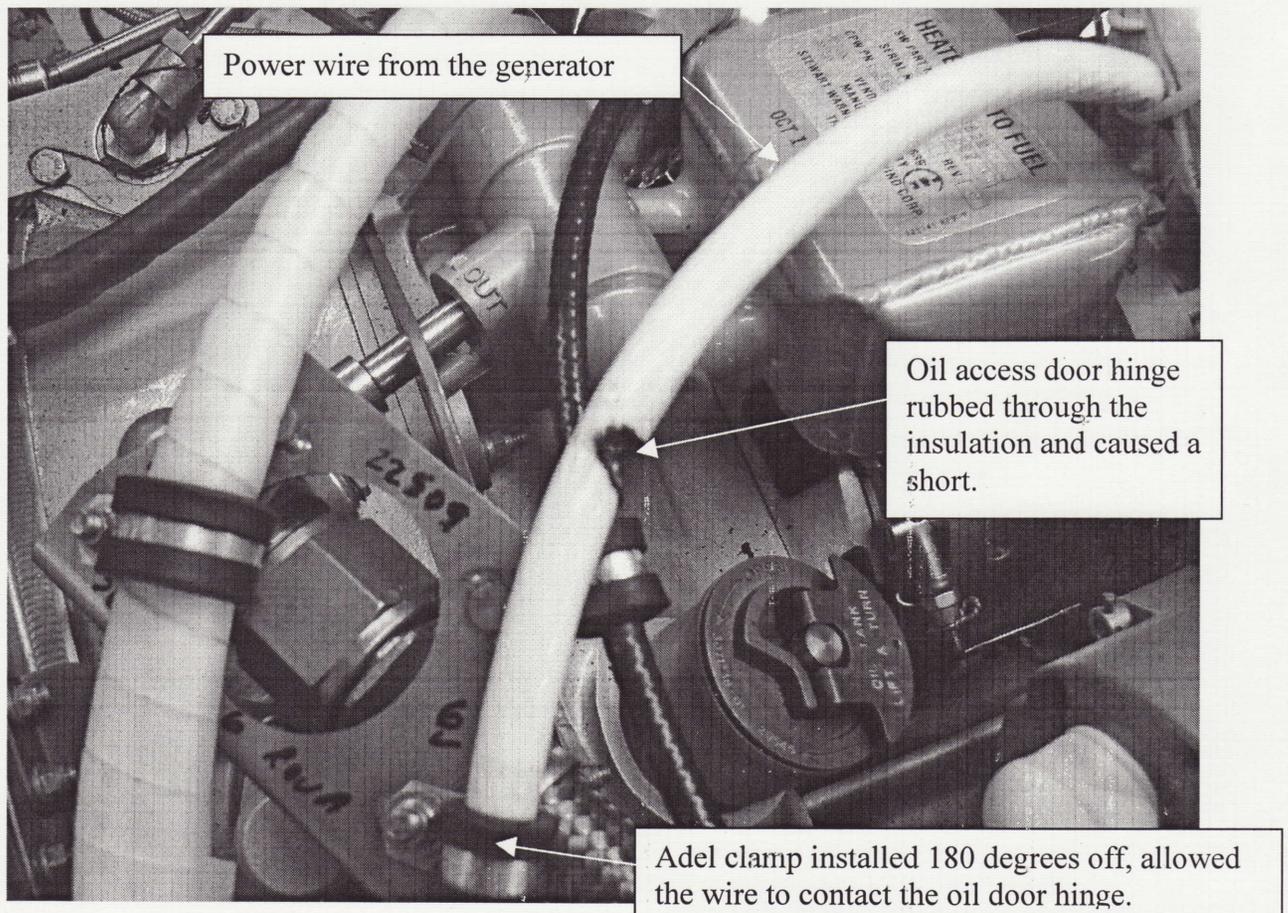
PROBLEM IDENTIFIED: It has been discovered that an improperly routed primary power wire from the generator could contact the oil access door hinge and over time wear through the insulation causing an electrical short and potential electrical fire (Figure 1).

Figure 1. Improperly Routed Wire (Looking Down on the Accessory Gear Box Area)

- (2) **At the next maintenance event.** Remove the top cowling and inspect the electrical wiring from the generator to the firewall for security and chafing. If any chafing has occurred, correct the problem and replace and secure the wire as necessary. Special emphasis should be placed on the security of the wires around the oil access door hinge when the door is closed. The wires must be secure and there should be at least 1 inch of clearance between the wires and the door hinge when the door is closed. The adel clamp (on the 560.07.706 Cable Bracket attached to the oil line on the top of the engine) holding the primary power wire from the generator should be oriented as shown in Figure 3 to give the needed spacing between the wire and the oil door hinge. If the adel clamp is orientated improperly as shown in Figure 1, correct the

installation and change the orientation of the adel clamp to that shown in Figure 3. If the wire is too short after changing the adel clamp orientation, replace the wire. Please email JetProp if you find the adel clamp was installed improperly or any other problems are identified. Some of the early aircraft may not have exactly the same wire routing. However, the clearance requirements and wire security are still the same.

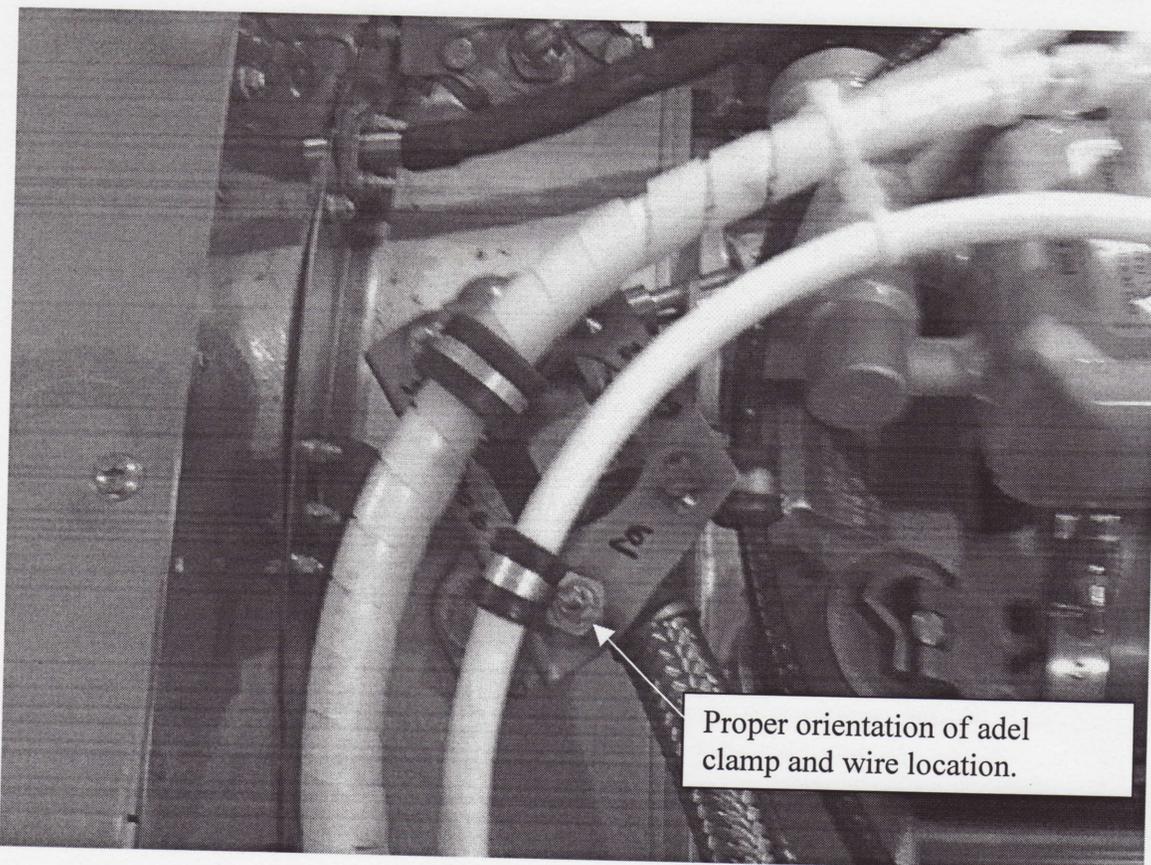
Figure 3. Properly Routed and Secured Wires
