S.I.L. NO. 03-560-06

SERVICE INFORMATION LETTER

FROM: JetProp LLC

SUBJECT: Auto Ignition Pressure Switch Location

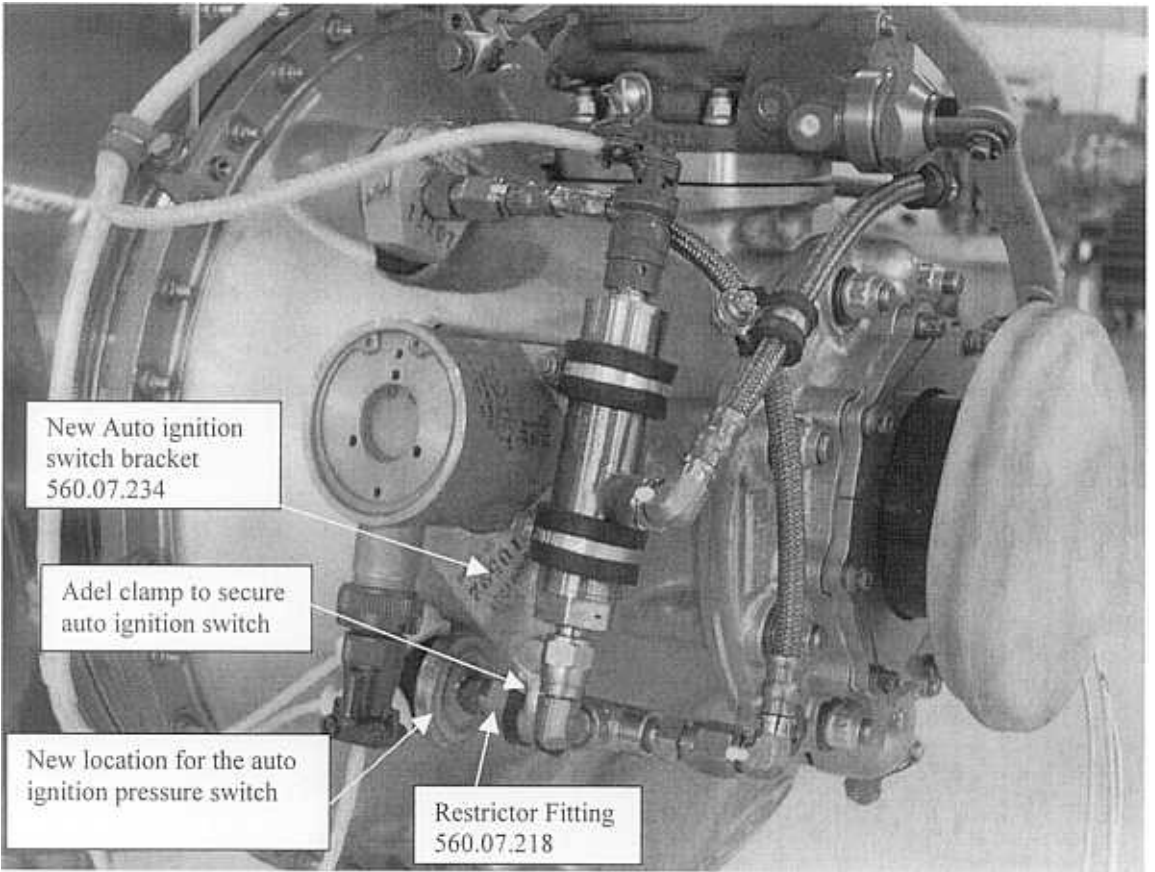
We recommend revising the configuration of the plumbing for the auto ignition pressure switch located of the forward right side of the engine. The new configuration is shown in Figure 1 below. This configuration should help isolate the pressure switch from vibration and result in a longer service life for the pressure switch. This new configuration does require a new bracket to help shock mount the pressure switch and an additional adel clamp and hardware.

- a. Remove the top cowling.
- b. Reconfigure the plumbing for the torque transducer and auto ignition pressure switch as shown in Figure 1.
- c. Use a little fuel lubricant (or equivalent) on the pipe fittings.
- d. Perform an engine run to ensure there are no leaks and that the auto ignition switch functions properly.
- e. Replace the top cowling.
- f. Make a log book entry stating that the auto ignition pressure switch was relocated in accordance with JetProp Service Information Letter 03-560-06.
